Project: Civic Centre, Plymouth

Re-Fixing & Securing and Concrete Repairs

Main Contractor: SWCR Ltd

Date: July 2010

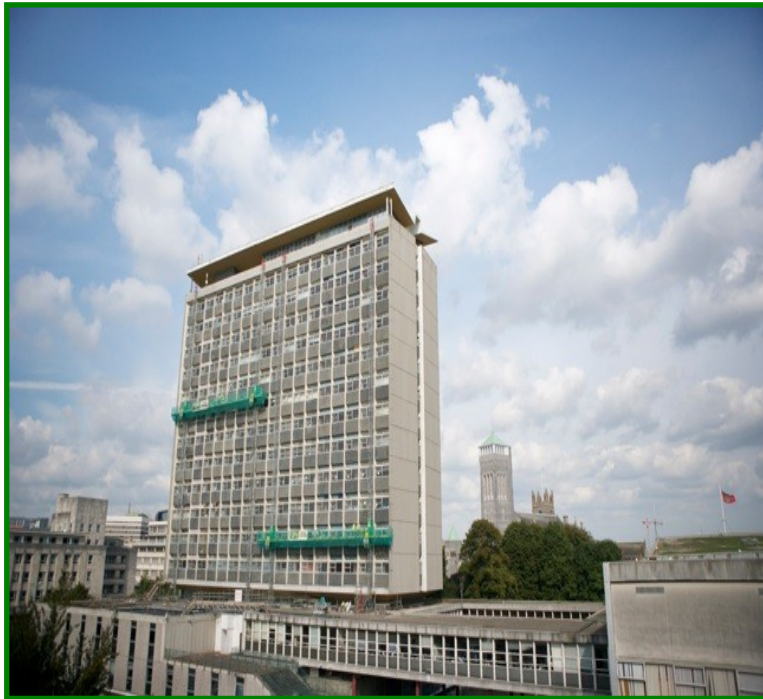
Following investigation and survey work carried out by The John Grimes Partnership (Structural Engineers), some pilaster cladding sections were identified as loose due to inferior fixings incapable of resisting the expansive forces created through the deterioration of the reinforced concrete frame to which they were attached. With each pilaster weighing around 25kg any that failed and fell could prove lethal to pedestrians using the building.

South West Concrete Repairs were contracted to secure all the pilasters by drilling proprietary concrete screws through the pilasters and into the concrete structure behind. Visibly distorted pilasters or having signs of severe frame distortion behind were removed, the main concrete frame repaired using traditional concrete repair techniques and the pilasters refitted.

Access was made using Masterclimbers fitted to the side of the building supplied by B.F.T Masterclimbing Ltd, and to ensure minimum disruption (dust and noise) to the buildings occupants works were carried out late afternoons, evenings and weekends.

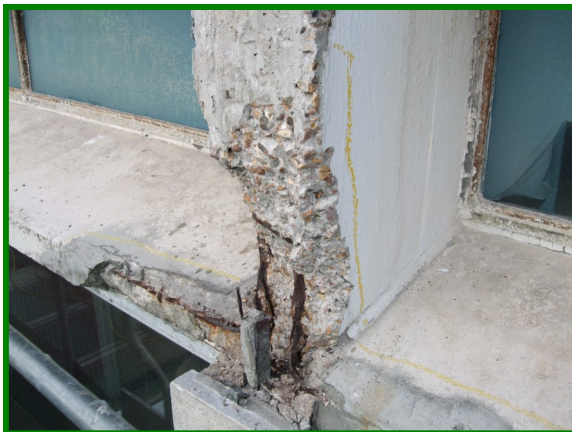
Spalling concrete to the face of the window feature with exposed reinforcement
